Palmer Home Inspections

Property Inspection Report

1234 Anywhere Street, Colorado Springs, CO 80916
Inspection prepared for: Mrs. Homebuyer
Real Estate Agent: No Agent - Personal Inspection-FSBO

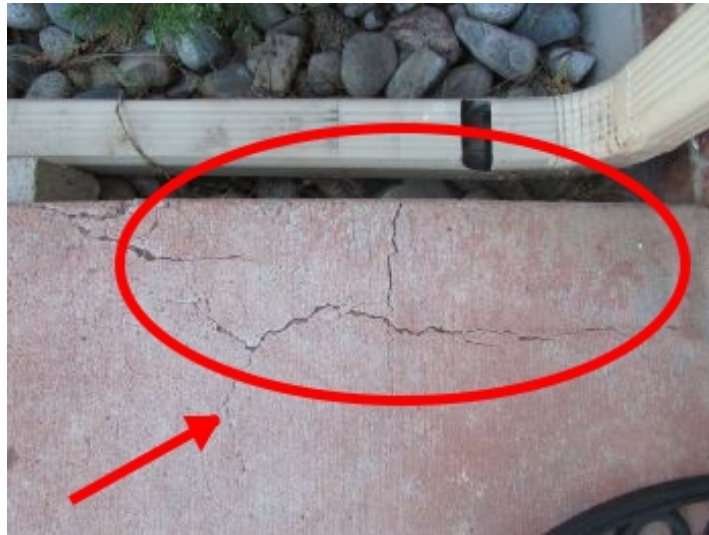
Grounds Porch/Patio

- Concrete porch appears in satisfactory and functional condition with normal wear for its age. Appears to be sound structure.
- Common cracks (1/4-inch or less) were visible on the porch. Cracks exceeding 1/4 inch should be filled with an appropriate material to avoid continued damage to the porch and patio surface from freezing moisture.

- Composite deck/patio appears in satisfactory and functional condition with normal wear for its age. Appears to be sound structure.

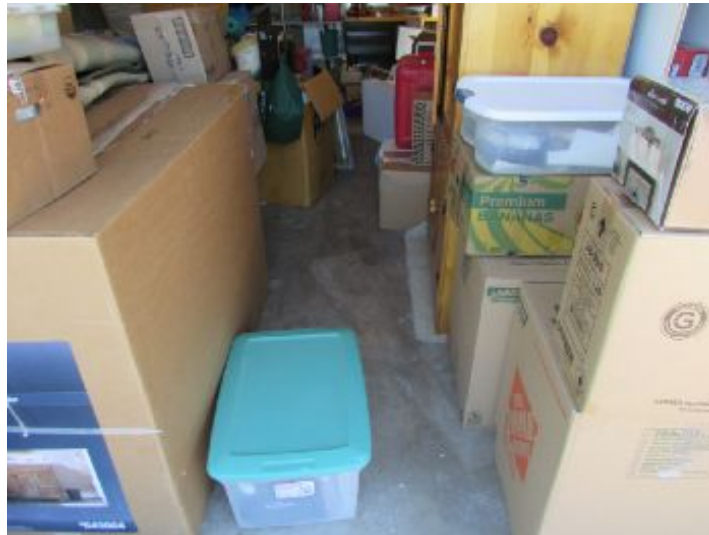
Garage Garage Floor Condition

- Garage floor was not completely visible due to personal items stored blocking view. Visible sections of garage floors are good.

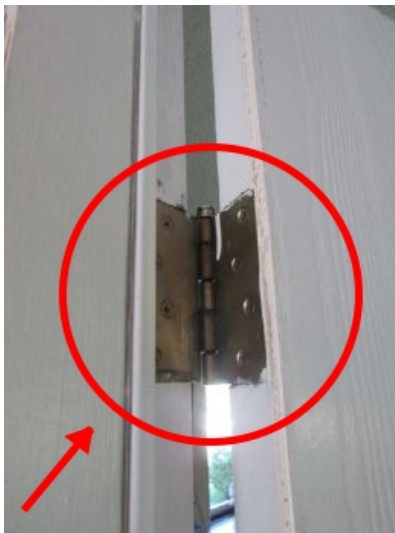
Garage Fire Door

- Appeared satisfactory and functional at the time of inspection.
- **No self-closing hinges. The door in the wall between the garage and the home living space did not have operable self-closing hinges as is required by generally-accepted current safety standards. Recommend installing self-closing hinges.**

Garage		
Page 10 Item: 10	Fire Door	<ul style="list-style-type: none"> • No self-closing hinges. The door in the wall between the garage and the home living space did not have operable self-closing hinges as is required by generally-accepted current safety standards. Recommend installing self-closing hinges.
Page 11 Item: 14	Garage Door's Reverse Status	<ul style="list-style-type: none"> • The door requires a great deal of resistance to trigger the auto-reverse mechanism. HIGHLY recommend having the garage door and opener serviced by a qualified professional.
Kitchen		
Page 15 Item: 8	Oven & Range	<ul style="list-style-type: none"> • Anti-tip bracket is missing from range installation. Recommend installing anti-tip brackets for safety.
Bedroom #1		
Page 19 Item: 2	Closets	<ul style="list-style-type: none"> • The closet light is missing fixture globe. This can be a potential fire hazard if clothing comes in contact with an exposed light bulb. Recommend installing the globe or install a light fixture with a cover.

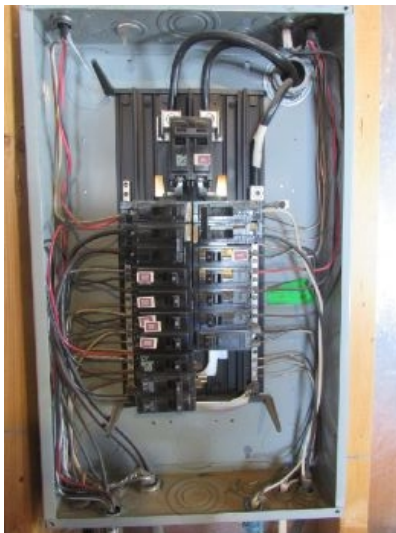
Electrical Electrical Panel

- Generally speaking, the electrical system appears to be in good order. All breakers are properly sized.

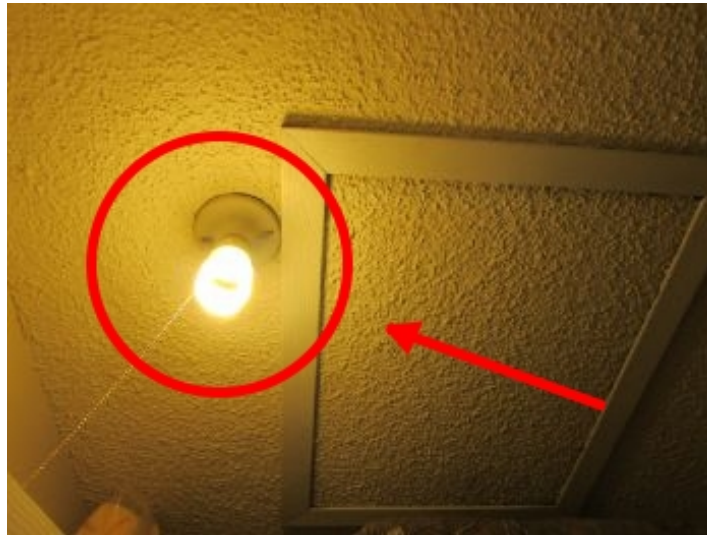
Bedroom #1 Closets

- The closet is in serviceable condition.
- The closet light is missing fixture globe. This can be a potential fire hazard if clothing comes in contact with an exposed light bulb. Recommend installing the globe or install a light fixture with a cover.

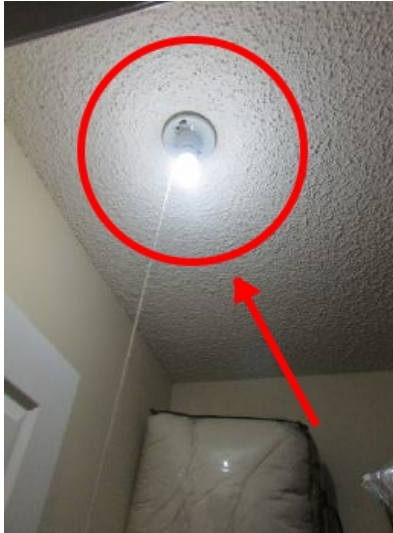
Bedroom #2 Closets

- The closet is in serviceable condition.
- The closet light is missing fixture globe. This can be a potential fire hazard if clothing comes in contact with an exposed light bulb. Recommend installing the globe or install a light fixture with a cover.

Bedroom #2		
Page 21 Item: 2	Closets	<ul style="list-style-type: none"> • The closet light is missing fixture globe. This can be a potential fire hazard if clothing comes in contact with an exposed light bulb. Recommend installing the globe or install a light fixture with a cover.

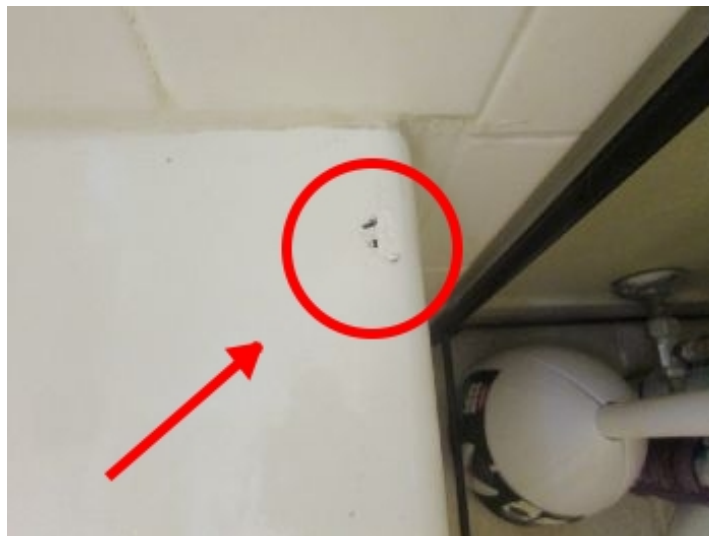
Bathroom #1 Bath Tubs

- Small chip in the surface noted.

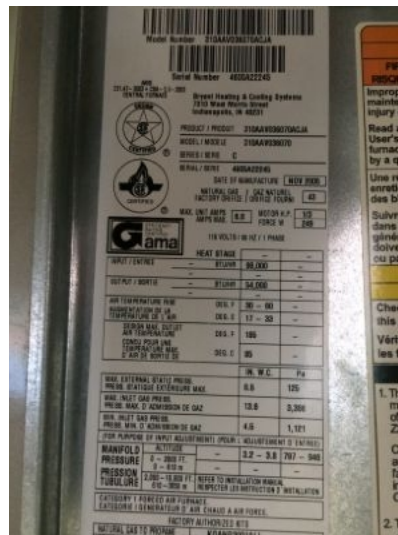
Heat/AC Heater Condition

Observations: The furnace is located in the mechanical room closet.
 Materials/Observations: Gas fired forced hot air noted. • Manufacturer: Bryant. • Manufacturer Date: 11/2006. • Model # 310AAV036070. • Serial # 4605A22245.

Observations:
 • At the time of the inspection, the Inspector observed no deficiencies in the condition of this furnace. Furnace was last serviced in 1/2017.

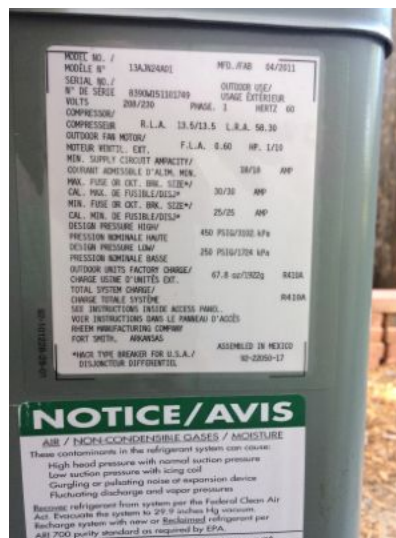
Heat/AC AC Compress Condition

Compressor Type & Manufacturer: Electric noted. • Manufacturer: Rheem. • Manufacturer Date: 4/2011. • Model # 13AJN24A01. • Serial # 8390W151101749.

- The system and it's components are considered to be in good condition.
- The system responded properly to the operating controls.
